SQ'EWÁ:LXW
SKAWAHLOOK FIRST NATION

Integrated Strategic Plan

Part B - Land Use Plan

Air Photo Time Series 1928 to 2004

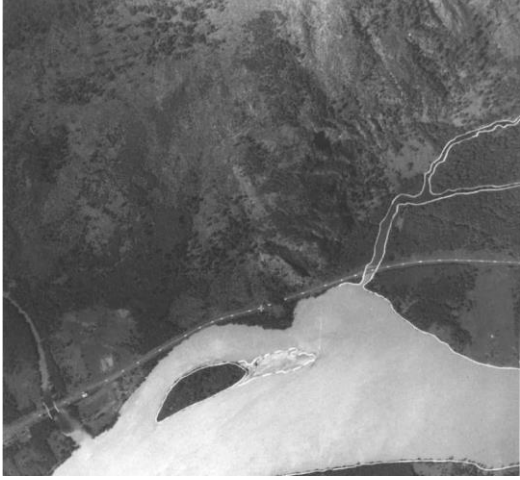
<p>1928</p> <p>Large portions of both reserves appear to have been cleared for agriculture. The CPR rail line is visible and appears to not have jeopardized the access to, and flow from, Skwawolt Creek which empties into an open bay. A single building is visible adjacent to the CPR east of Ruby Creek. There appears to be a single building on Skawahlook IR #1. A small number of buildings appear to be located in the centre of Ruby Creek #2.</p> <p>Vasasus Island is much smaller than at present.</p>

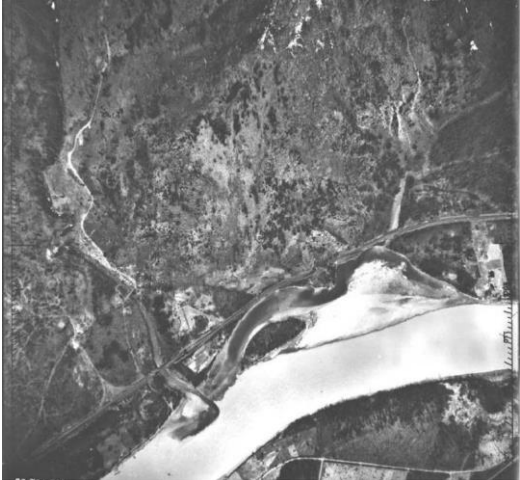
<p>1949</p> <p>IR #1 appears to be similar to 1928, although the fields appear to be more symmetrical and under cultivation.</p> <p>There appear to be 4-5 buildings located south of the CPR and east of Ruby Creek.</p> <p>A significant amount of timber seems to have been removed from the hillside behind Ruby Creek #2.</p> <p>A large logging camp is located on the west end of Ruby Creek IR #2 North. There are approximately 20 buildings. Ruby Creek has been bridged near the logging camp by a road extending to the north on the east side of Ruby Creek through <i>Lukseetsissum</i> IR #9 to the Fraser River on the west side.</p> <p>Vasasus Island remains a similar size as in 1928 but the bay appears to be getting more shallow.</p>

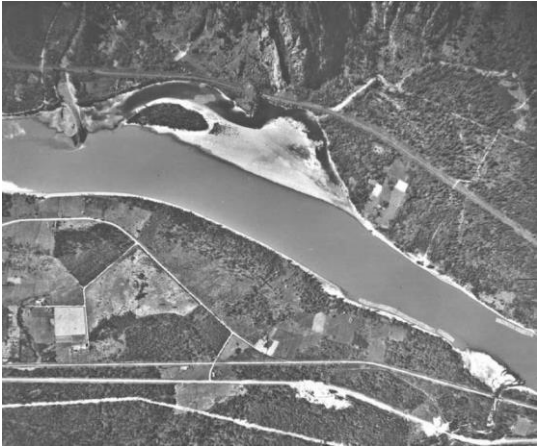
<p>1954</p> <p>IR #1 is similar to 1949 except it has two buildings on the reserve and the road from the Fraser along the east boundary has been built. A clearing near the rail line that appeared in the 1949 photo now contains a number of unresolved structures.</p> <p>The fields on IR #2 appear to be growing in with shrubs or trees.</p> <p>There appear to be three large above ground tanks or buildings located on the south side of the CPR, east of Ruby Creek.</p> <p>New disturbed ground is visible in the area of the highway works yard, northeast of IR #2.</p> <p>The shallowing of the bay east of Vasasus Island appears to continue.</p>

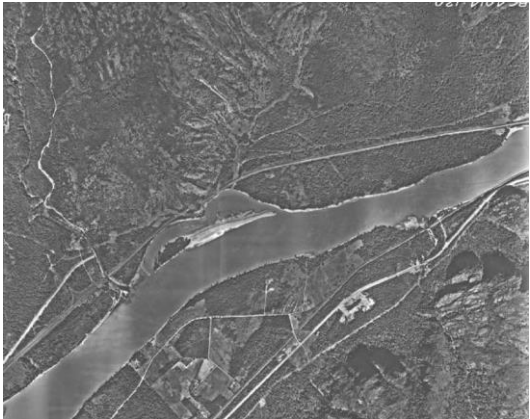
<p>1961</p> <p>The gas pipeline has appeared running through both reserves.</p> <p>The fields on IR #1 have become overgrown and no buildings are evident.</p> <p>On IR#2 the logging camp remains.</p> <p>A new protective breakwater appears built out into the Fraser River which may explain the rapid accretion of a much enlarged Vasasus island.</p> <p>The CPR buildings appear to have been removed.</p> <p>The highway has arrived at Ruby Creek from the west but does not cross.</p>

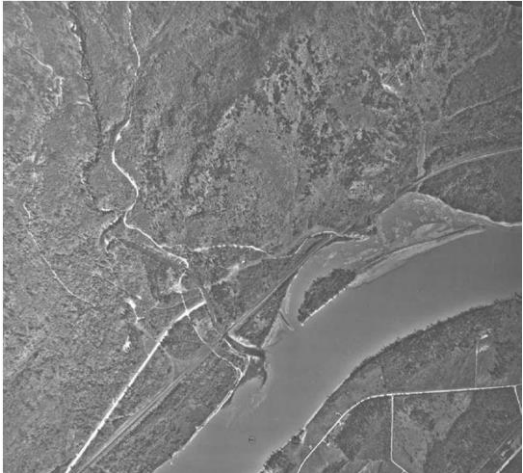
<p>1963</p> <p>IR # 1 is completely overgrown.</p> <p>Ruby Creek #2 is similar to 1961 but a large rectangular building has appeared. The fields on the south side of #2 appear to be abandoned.</p> <p>The logging camp remains.</p> <p>In addition to crossing Ruby Creek, the logging road has now been extended westward across the north side of IR #2 and then swings south to terminate at the Fraser River in the bay protected by Vasasus Island and at the rock bluff point.</p>

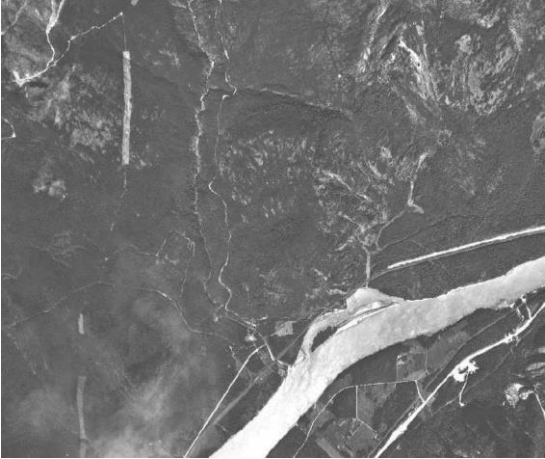
<p>1966</p> <p>Similar to 1962 with all areas overgrown except for a large clearing on IR #2 bisected by the pipeline and in the general vicinity of the current administration office.</p> <p>No progress on the highway coming from the west but it is approaching Skwawolt Creek from the east. Skwawolt Creek remains open to the Fraser River.</p>

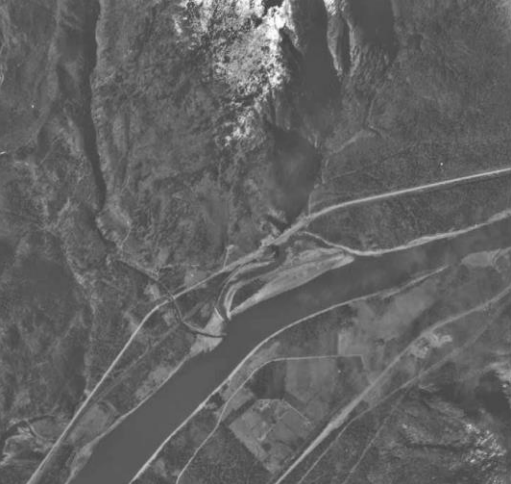
<p>1971</p> <p>Land use similar to 1966.</p> <p>The highway now passes through both reserves but does not yet bridge Ruby Creek. Skwawolt Creek is now cut off from the Fraser River.</p> <p>The logging roads are brushing-in, and the bridge over Ruby Creek is gone.</p>

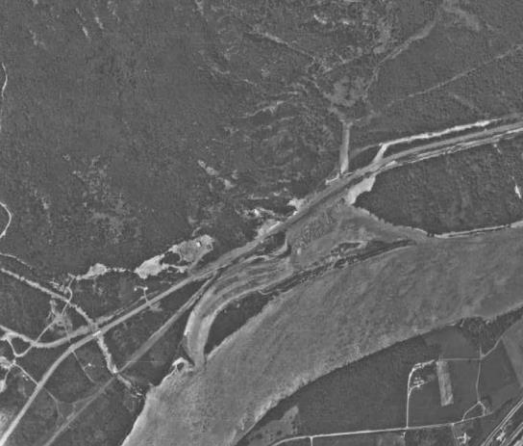
<p>1973</p> <p>IR #1 remains totally overgrown but a road has been added to the Fraser and along the river bank. IR #2 is overgrown including the opening visible in 1966 and 1971 (administration building area), however a new highway access to this area and across the hwy has been added.</p> <p>The highway is now bridged over Ruby Creek. The highway maintenance yard is established with two large buildings.</p> <p>The second pipeline is being constructed.</p> <p>The logging road and bridge over Ruby Creek has been re-established.</p>

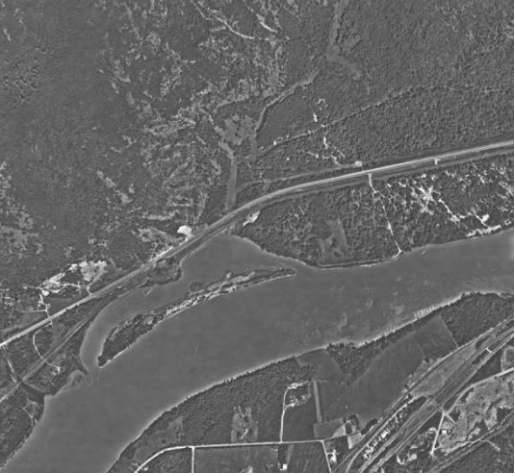
<p>1979</p> <p>The current clearing on the south portion of IR #1 now appears. There are no buildings. There are scattered openings and minor logging roads on the north side of IR #1.</p> <p>The developments on the north side of IR #2 have begun. The residence IR #2 south of the tracks now appears.</p>

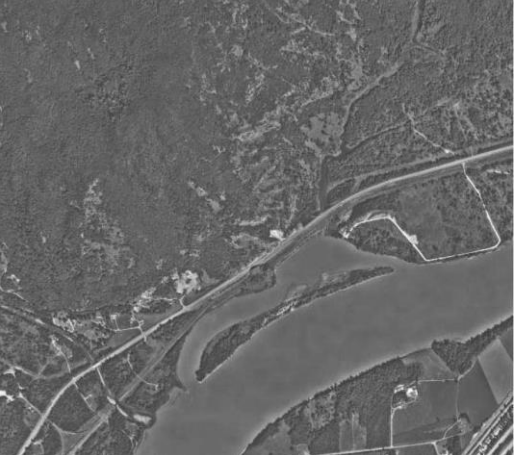
<p>1983</p> <p>The road on IR #1 South, and to some extent IR #1 North has been further developed.</p> <p>The opening on IR #1 South is larger, and a logging has significantly reduced the stocking of trees throughout IR #1 south.</p> <p>More development in the IR # 2 North, including clearing toward Ruby Creek. The logging road bridge is gone.</p>

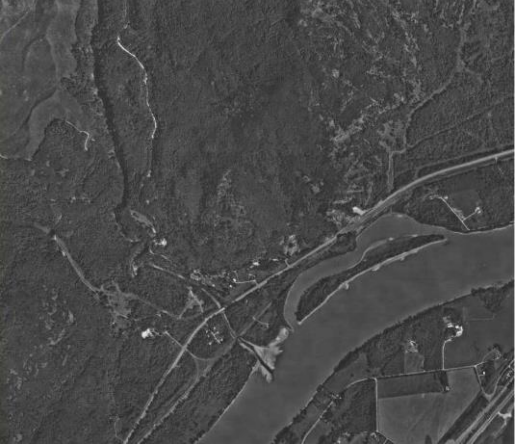
<p>1992</p> <p>The home on IR #1 South has been built. The north end of the opening, south of the highway is brushing in.</p> <p>IR #2 is much the same as in 1983.</p>

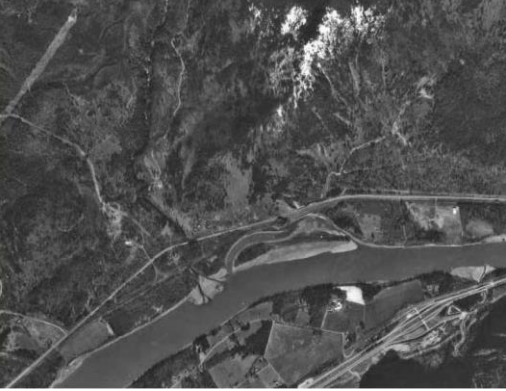
<p>1999</p> <p>Similar land use to 1992. The highway yard buildings seem to be gone.</p>

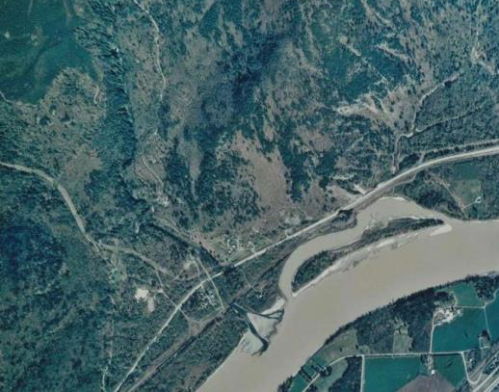
<p>2004</p> <p>Deposition of material by the Fraser River has created additional land on IR #2 South, just downstream from the groin.</p> <p>Land use is similar to the current use, with the exception of the absence of the administration building.</p>
